CENTER ROAD BRIDGE 87 REPLACEMENT

TOWN OF HARDWICK, VERMONT

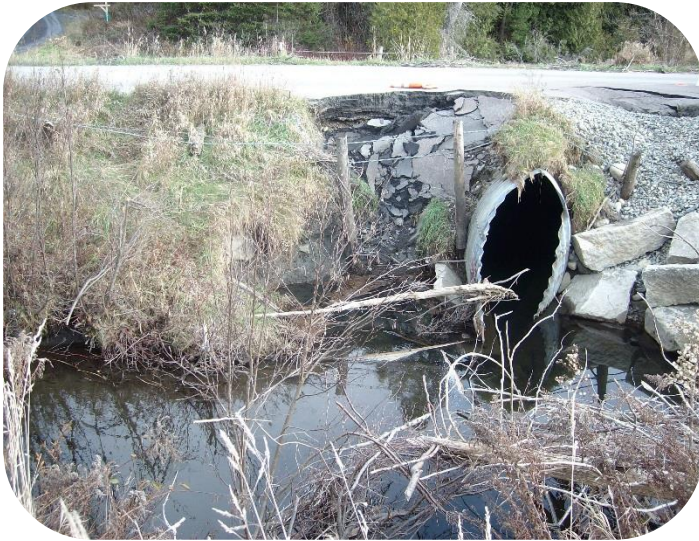
Metal Arch Structure Damaged during Tropical Storm Irene

Bridge No. 87 on Center Road in Hardwick, a Federal Aid Highway, was damaged during Tropical Storm Irene. Initial evaluations by Federal Inspectors suggested the existing structure could be repaired, and suggested an evaluation by an engineer. DG provided engineering assistance to survey the site and evaluate the existing structure and stream channel, and determined the existing structure was hydraulically inadequate and damaged beyond repair.

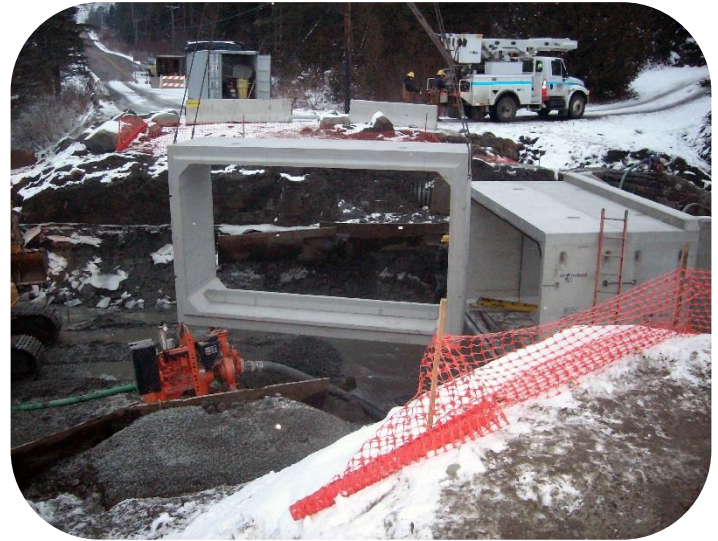
Construction Workers Set New 15-foot x 9-Foot Box Structure

DG worked with Town, VTrans and Federal Highway Administration officials to secure funding to replace the structure using FHWA Emergency Funding. DG prepared plans and bid documents, obtained approvals and permits from VTrans, FHWA and the State of Vermont Agency of Natural Resources and assisted the Town in soliciting bids for the new 9 foot by 16 foot structure, which would be buried 3 feet to provide aquatic organism passage.
