Completed Brownington Bridge

Bridge No. 1 over the Willoughby River was damaged beyond repair during Tropical Storm Irene. Floodwaters overtopped the bridge and scoured the southern abutment, causing it to undermine then shift into the stream dropping the southern side of the deck approximately 5 feet from the road, leaving it partially suspended above the river. FEMA, Agency of Natural Resources and Fish and Wildlife Officials agreed that the damaged structure needed to be removed prior to the spring thaw to prevent further damage to the Willoughby River, which is a valued salmon and trout spawning ground in the Northeast Kingdom of Vermont. DG was hired to prepare bid documents and solicit bids for the removal of the structure immediately, and DG worked with Eckman Engineering to complete final designs and bid documents for a separate contract for the reconstruction of the new structure.

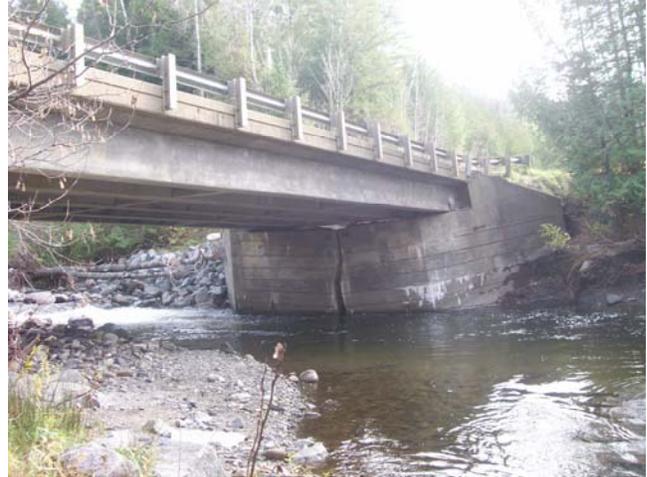
Damaged Structure, Note Abutment in River

The State of Vermont Agency of Natural Resources would not allow construction of the structure without increasing the span to meet the required minimum channel width based on ANR calculations and the hydrology and hydraulics of the site. FEMA determined the additional length of the structure would not be eligible for reimbursement from FEMA grants, so DG worked with the Towns of Brownington and Barton to secure a Town Highway Structures Grant to pay for the additional length and to include approach slabs to ensure longevity of the structure.
