Bridge No. 87 on Center Road in Hardwick, a Federal Aid Highway, was damaged during Tropical Storm Irene. Initial evaluations by Federal Inspectors suggested the existing structure could be repaired, and suggested an evaluation by an engineer. DG provided engineering assistance to survey the site and evaluate the existing structure and stream channel, and determined the existing structure was hydraulically inadequate and damaged beyond repair.

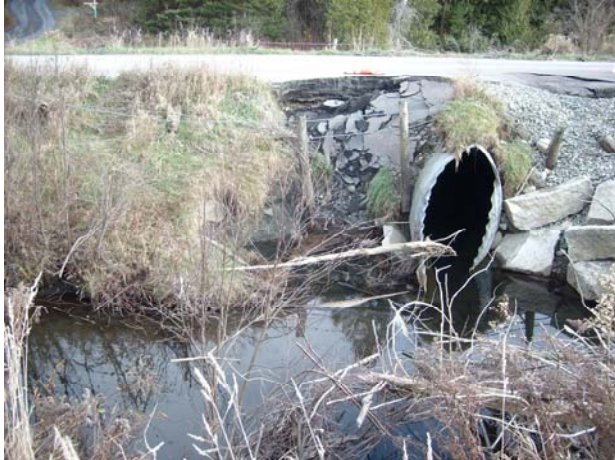
**Metal arch structure damaged during Tropical Storm Irene**

DG worked with Town, VTrans and Federal Highway Administration officials to secure funding to replace the structure using FHWA Emergency Funding. DG prepared plans and bid documents, obtained approvals and permits from VTrans, FHWA and the State of Vermont Agency of Natural Resources and assisted the Town in soliciting bids for the new 9 foot by 16 foot structure which would be buried 3 feet to provide aquatic organism passage.

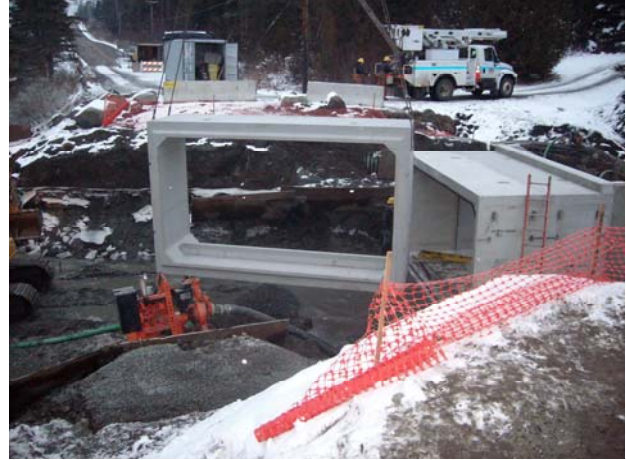
**Construction workers set new 9 foot x 15 foot box structure (note baffler designed to hold natural stream material)**

- Project received 100% reimbursement from FHWA for Emergency Repairs since contract documents and bid process followed FHWA standards.
- Construction completed and road re-opened within 125 days of initiation of preliminary engineering.
- Irreparably damaged metal arch replaced with precast concrete box culvert.
