14-INCH TRANSMISSION MAIN CLEANING AND LINING

ST. JOHNSBURY, VERMONT

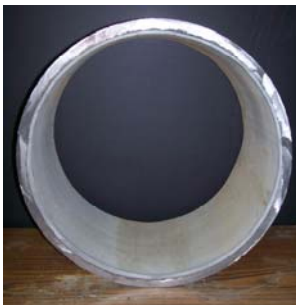
Before

Cleaning scrapers are pulled through the water main to remove any mineral buildup that is present.

Construction activity during the summer of 2009 was intense as multiple Water Distribution Upgrades were performed by the Town of St. Johnsbury, VT. One of these projects included the cleaning and cement lining of 6,700 lf of the unlined cast iron 14-inch source transmission water main that was originally installed in 1934.
