The 80 ft long Missing Link Bridge (Bridge #13) over the Williams River was damaged beyond repair during Tropical Storm Irene when high flows of 12,000 cfs scoured the river bed, resulting in failure of the southern abutment and causing the bridge to drop approximately 5 feet at the south end.

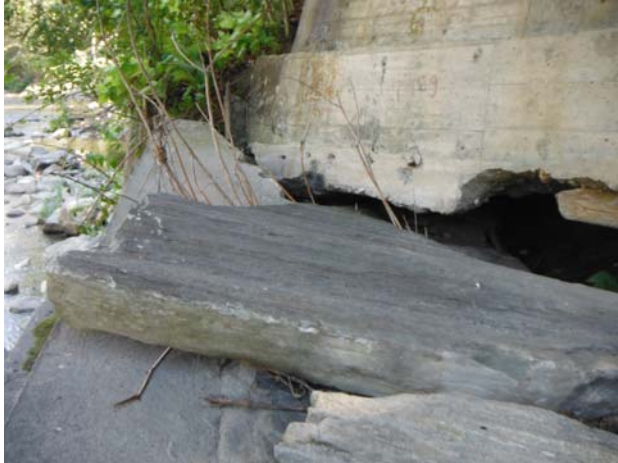
*Damaged abutment*

After completing a hydrology and hydraulics report, Dufresne Group recommending replacing the bridge with a 90 ft long structure with precast concrete deck panels over rolled steel beams and a deep driven piling foundation for scour resistance.

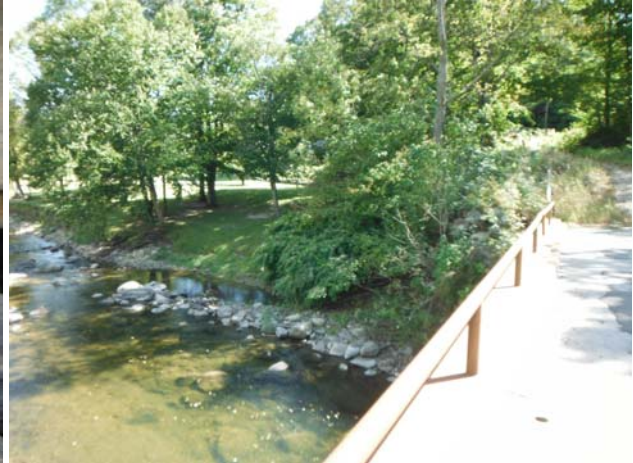
*Downstream during low flow conditions*
