OKEMO MOUNTAIN ACCESS ROAD CULVERT REPLACEMENT LUDLOW, VERMONT

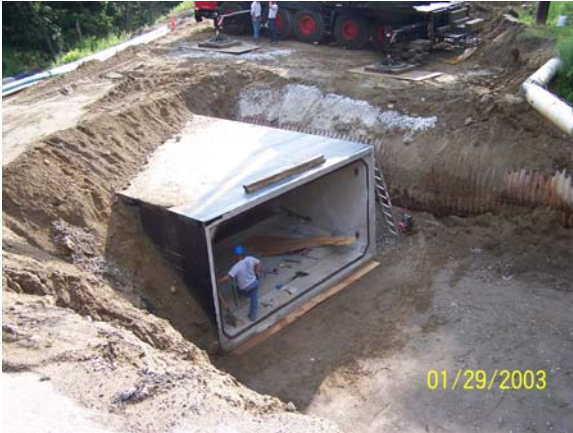
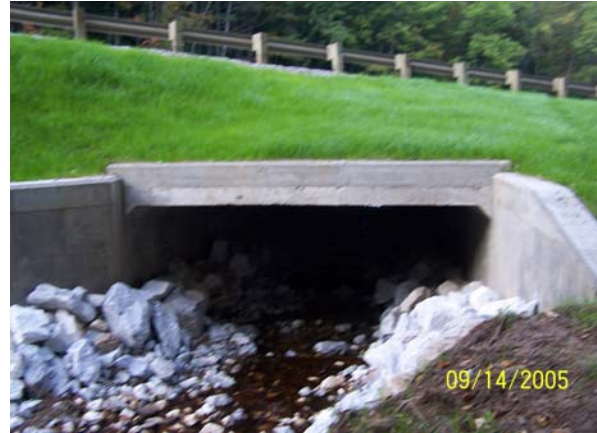
The access road to Okemo Mountain Ski Resort in Ludlow, VT crosses a stream which has springtime flows of 650 cfs. The former stream crossing utilized a nine foot diameter steel plate culvert. The culvert bottom was corroded which allowed water to pass in and out of the culvert structure, eroding the gravely sands that formed the backfill around the culvert. This caused sagging of the road surface over the culvert and significant sink holes around the culvert itself.

There were significant challenges with the culvert design to meet the Fish and Wildlife criteria for fish passage. The final solution was to construct the culvert with interior stilling basins to trap natural stream materials and provide riprap along the culvert walls to provide fish resting areas.
