Bridge No. 9 on Stannard Mountain Road, in Stannard, Vermont was damaged as a result of Tropical Storm Irene. Initial evaluations by FEMA inspectors indicated that the structure was old and damaged prior to the storm and would not be eligible for receipt of grants.

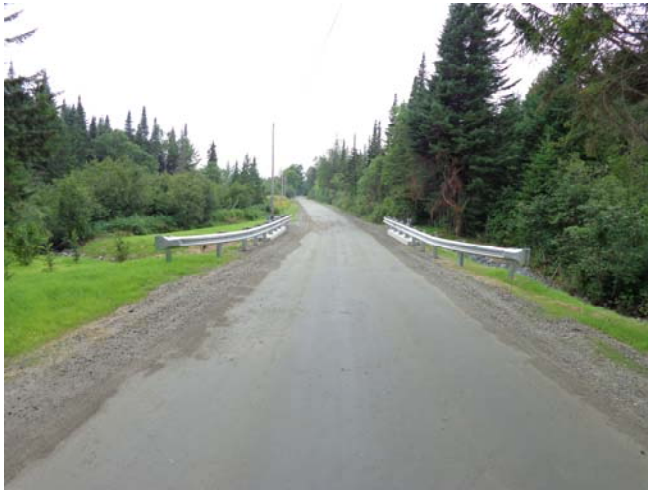
New Structure

The existing structure was replaced with an arch, or simple bridge structure with 22-foot span which was accepted by the Agency of Natural Resources and FEMA. DG worked with VTrans, and FEMA to include the cost of installing a temporary bridge structure during construction as reimbursable project expense.
