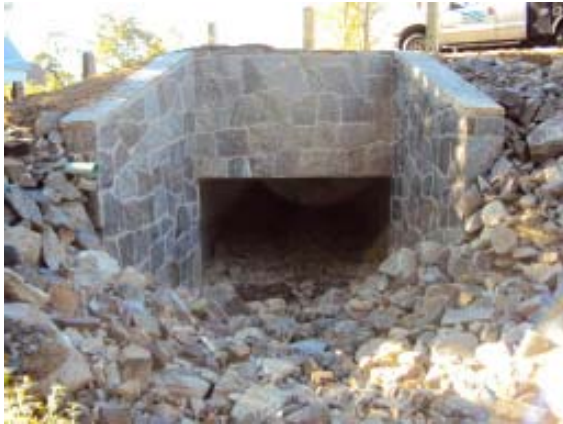
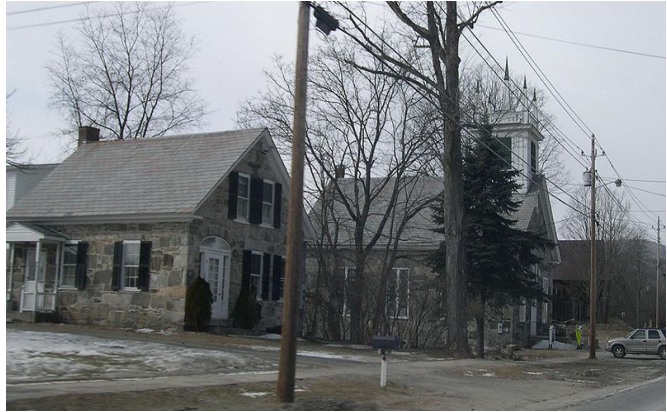
The existing 2.5' wide by 5.5' high laid up stone culvert crossing under Route 103 in the Chester Stone Village was deteriorated and in danger of collapsing. The sewer and water mains crossing the structure were vulnerable to damage in the event the culvert failed.

The culvert was replaced with a 100 ft long precast box culvert with a 10' wide by 6' high opening. The hydraulic capacity was significantly increased to pass the 50 year flood flow from Trebo Brook.

- Construction challenges included accommodating Route 103 heavy truck traffic without a detour route.
- Culvert location in Chester's Historic Stone Village required stone facing on the wingwalls and headwalls to meet Historic Preservation requirements.
- Replacement design incorporated a concrete box constructed with bed retention sills to hold native gravels to allow fish passage.
